# **CERTS MICROGRID LABORATORY TEST BED**

Test Plan Section 7.0  
Validate Protection Settings and  
Initial Fault Testing

# **CERTS MICROGRID TEST REPORT**

*“Validate Protection Settings and Initial Fault Testing”*

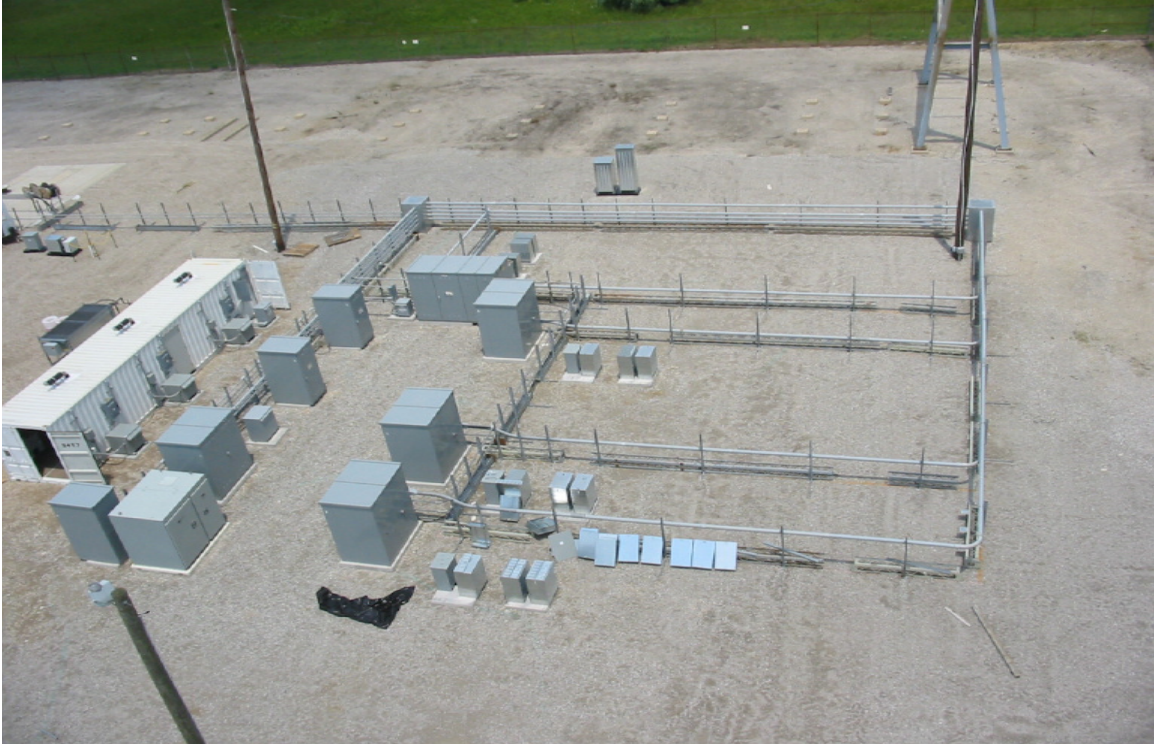
**Figure 1 - CERTS Microgrid Aerial Photo**

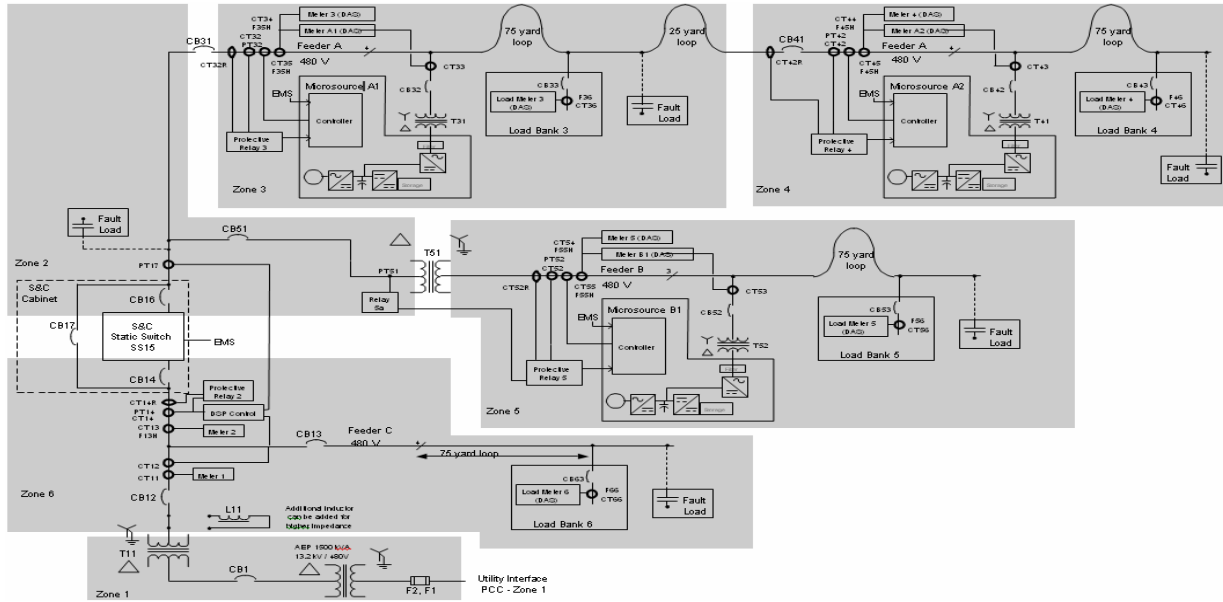
There are 6 zones in the Test Bed with Zones 2 - 6 contained within the CERTS Microgrid design and Zone 1 being the utility interface and referred to as the point-of-common coupling (PCC) to the grid. Each zone is protected by a Schweitzer SEL-351 relay. Faults of varying magnitude can be applied to each zone through an additional breaker which allows fault application and removal.

Figure 2 - One Line Diagram of CERTS Microgrid Test Bed

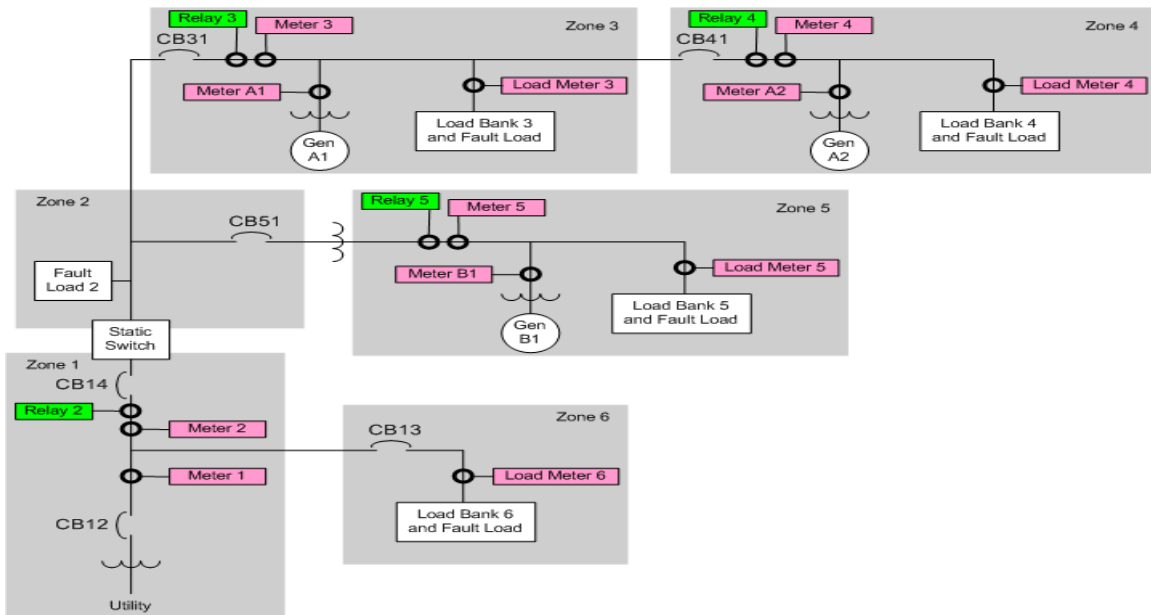
Figure 3 - Simplified diagram of Test Bed showing Meter and Relay locations

There are twelve PML ION 7650 meters placed through out the microgrid and shown in Figure 3, which monitor electrical system conditions, plus acquire phase current and voltage waveforms; and calculate RMS values of voltage, current, active power, reactive power, and frequency.

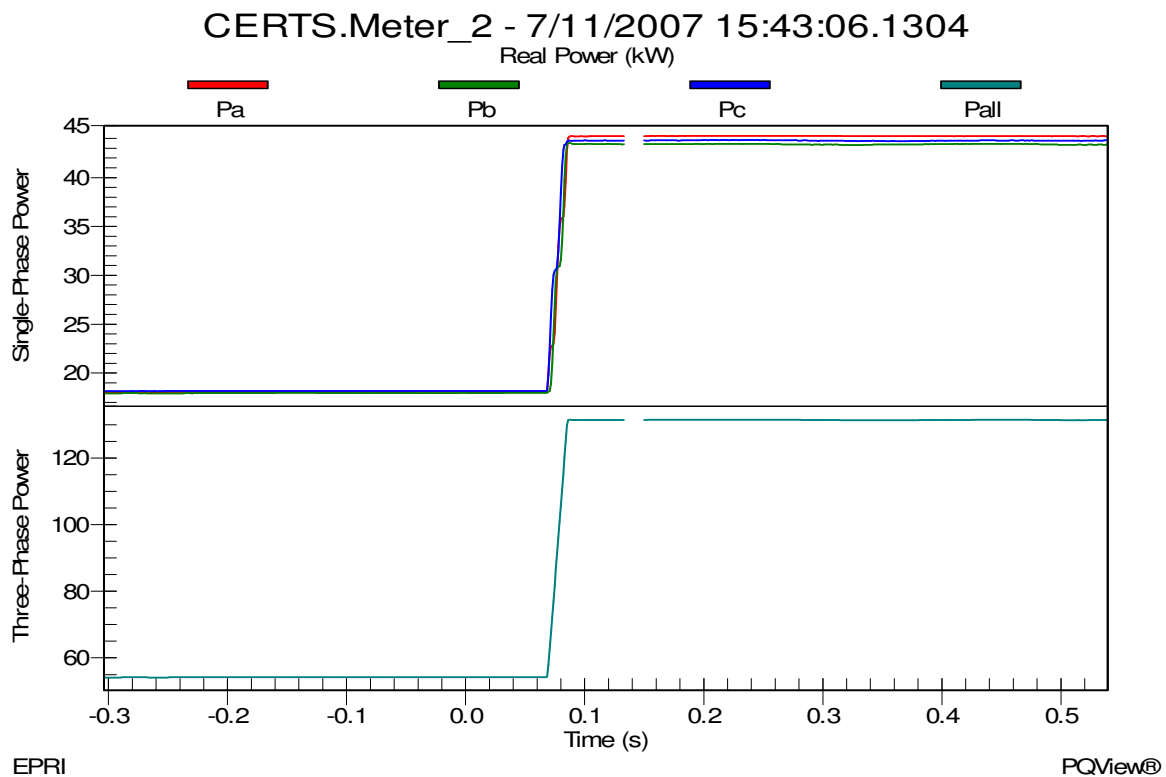
Figure 10a - Load in Zone 4 when the overload fault is initiated

Bed was connected to the utility grid with approximately 55kW at Meter 2. A simulated fault (i.e., Overload Load Bank of 85kW) with a duration set for 99 seconds was initiated to Zone 4 from the DAS Load Control Program. Figure 10a shows when the overload bank was initiated and the load in Zone 4 increased from approximately 55kW to 130kW.

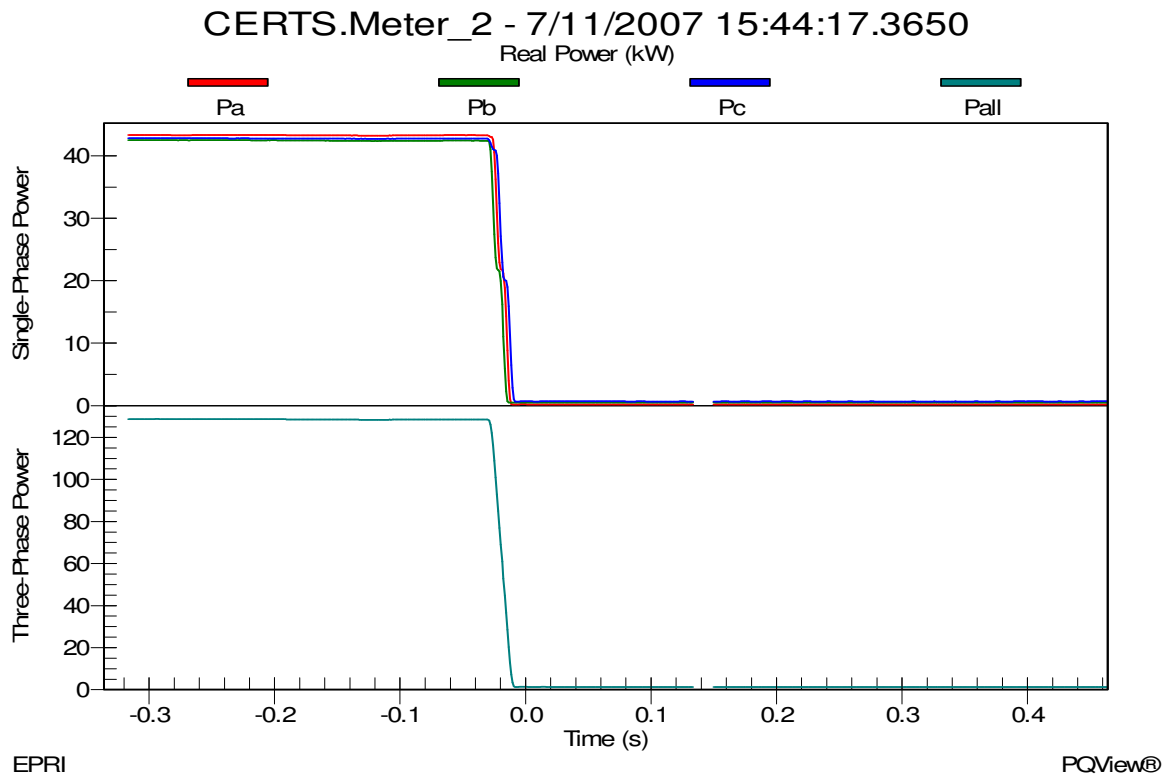
Figure 10b - Load in Zone 4 after circuit breaker CB41 "Opens" to isolate and clear the fault

When the load increased in Zone 4, CB41 internally detected an  $I^2t$  protection event and opened after 71.3 seconds, clearing the fault from Zone 4, shown in Figure 10b.

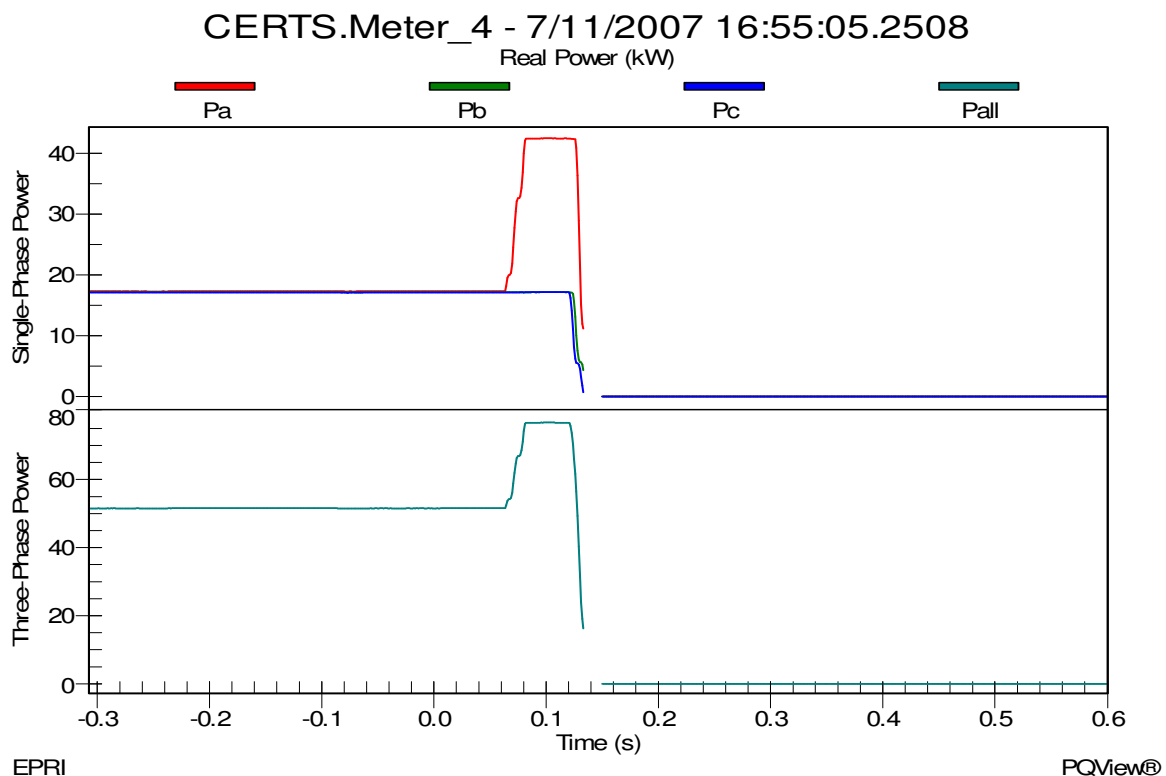
Figure 10d - Load in Zone 4 before/after the single phase-to-ground fault is applied

Bed was connected to the utility grid with approximately 51kW at Meter 2. A simulated overload fault (i.e., Overload Load Bank of 28.3kW on A-phase) with a duration set for 10 seconds was initiated to Zone 4 from the DAS Load Control Program. Figure 10d shows when the overload bank was initiated and load in Zone 4 increased from approximately 52kW to 75kW three-phase power and approximately 17.5kW to 41kW on A-phase. Also in Figure 10d, you can see where the fault is cleared and the load is reduced to 0kW.

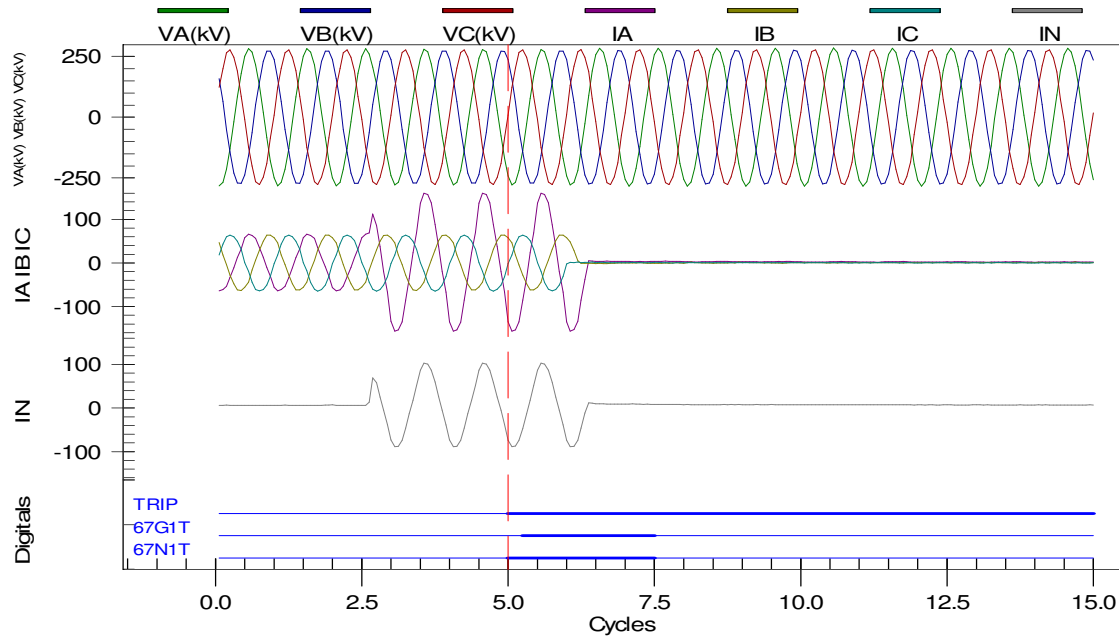
When the load increased in Zone 4, the static switch (i.e., Relay 2) detected a ground over-current (67N1T), shown in Figure 10e. The static switch opened after 0.023 seconds (1.5 cycles) clearing the fault from Zone 4, shown in Figures 10d and 10e.

Figure 10e - Voltages, Currents, and Ground Current (IN) at Relay 2 when the fault is detected and cleared by the static switch.

After the static switch opened, the breakers in protection zones (i.e., CB31 in Zone 3, CB41 in Zone 4 and CB51 in Zone 5) remained closed. This was expected since the fault was isolated and cleared by the static switch.

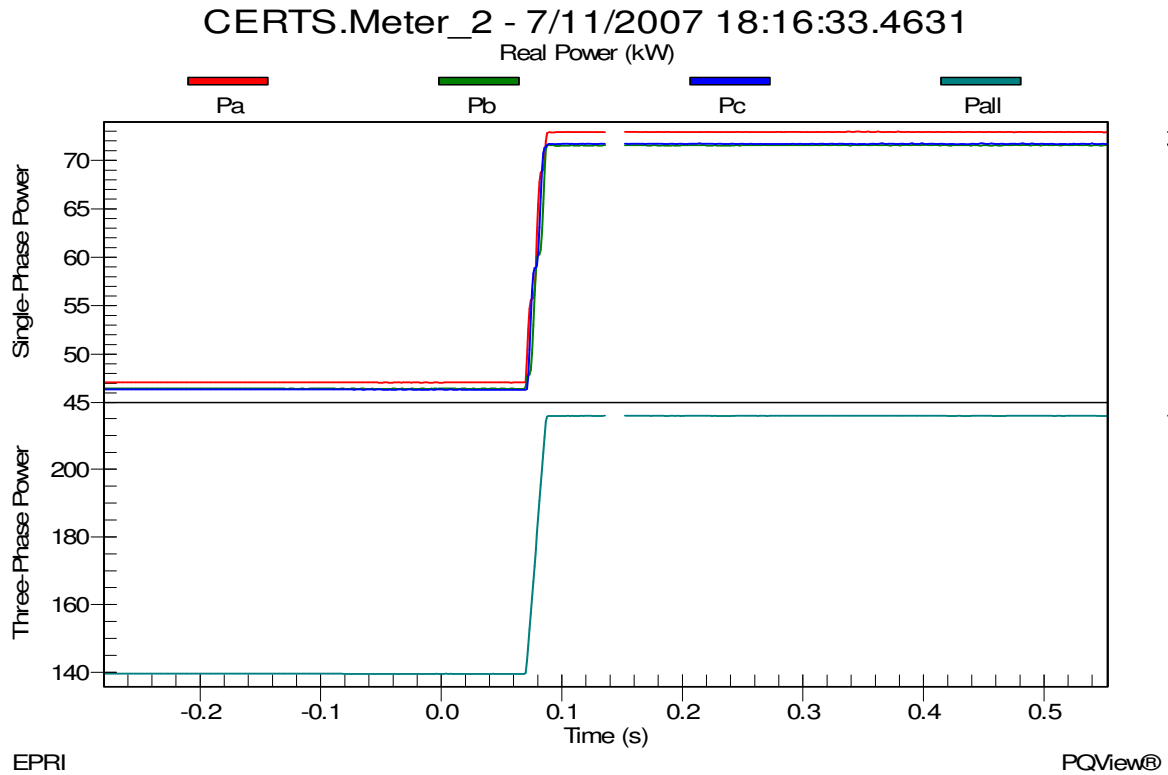
Figure 11a – Load change due to Zone 3 when the overload fault was initiated

Bed was connected to the utility grid with approximately 140kW at Meter 2. A simulated fault (i.e., Overload Load Bank of 85kW) with a duration set for 99 seconds was initiated to Zone 3 from the DAS Load Control Program. Figure 11a shows when the overload bank was initiated and load in Zone 3 increased from approximately 140kW to 220kW.

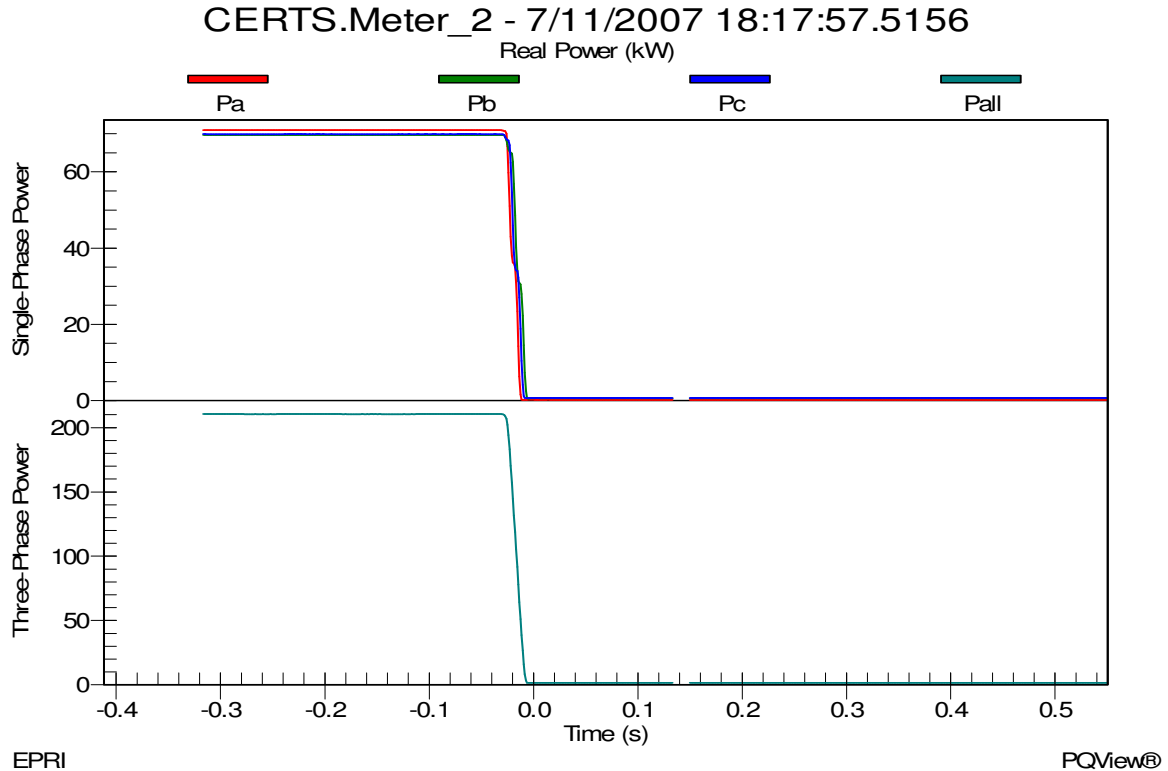
Figure 11b - Load change in Zone 3 after CB31 opened" to isolate and clear the fault

When the load increased in Zone 3, CB31 internally detected an  $I^2t$  protection event and opened after 84 seconds, clearing the fault from Zone 3, as shown in Figure 11b.

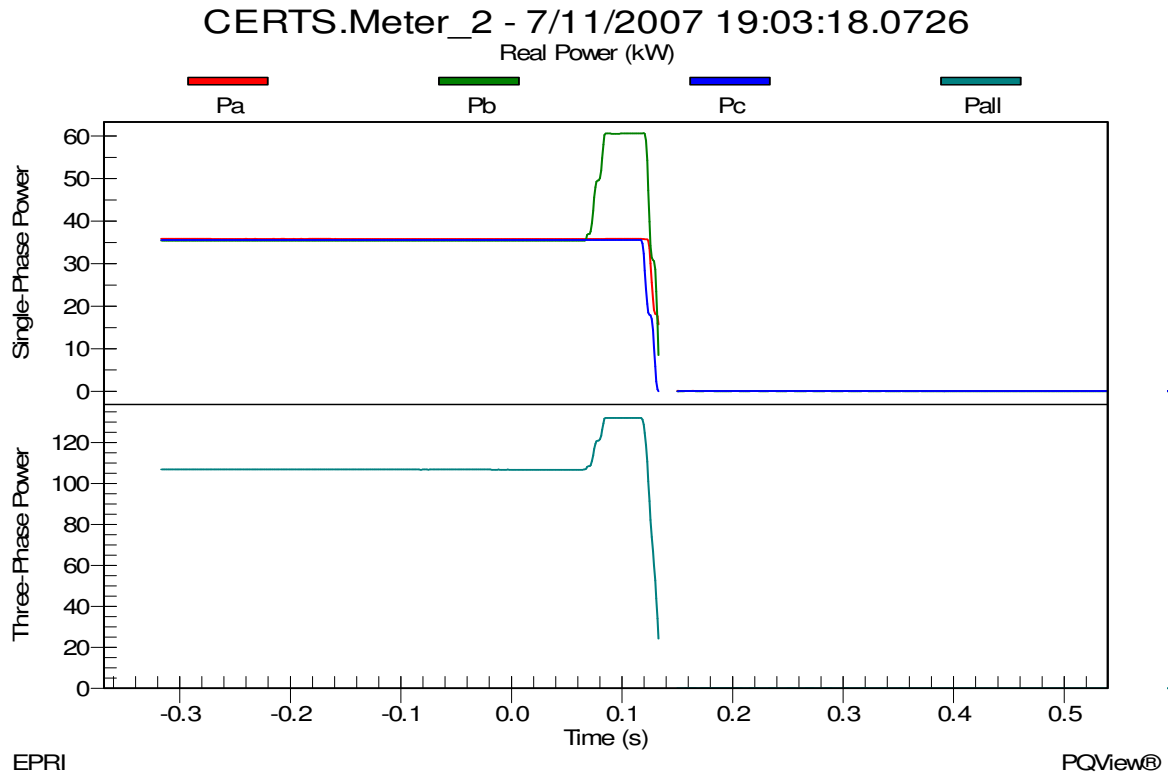
**Figure 11c - Load change before/after the single phase-to-ground fault was applied in Zone 3.**

10 seconds was initiated to Zone 3 from the DAS Load Control Program. Figure 11c shows when the overload bank was initiated and load in Zone 3 increased from approximately 111kW to 133kW three-phase power and approximately 35kW to 60kW on B-phase. Also, Figure 11c, shows where the fault is cleared and load is reduced to 0kW.

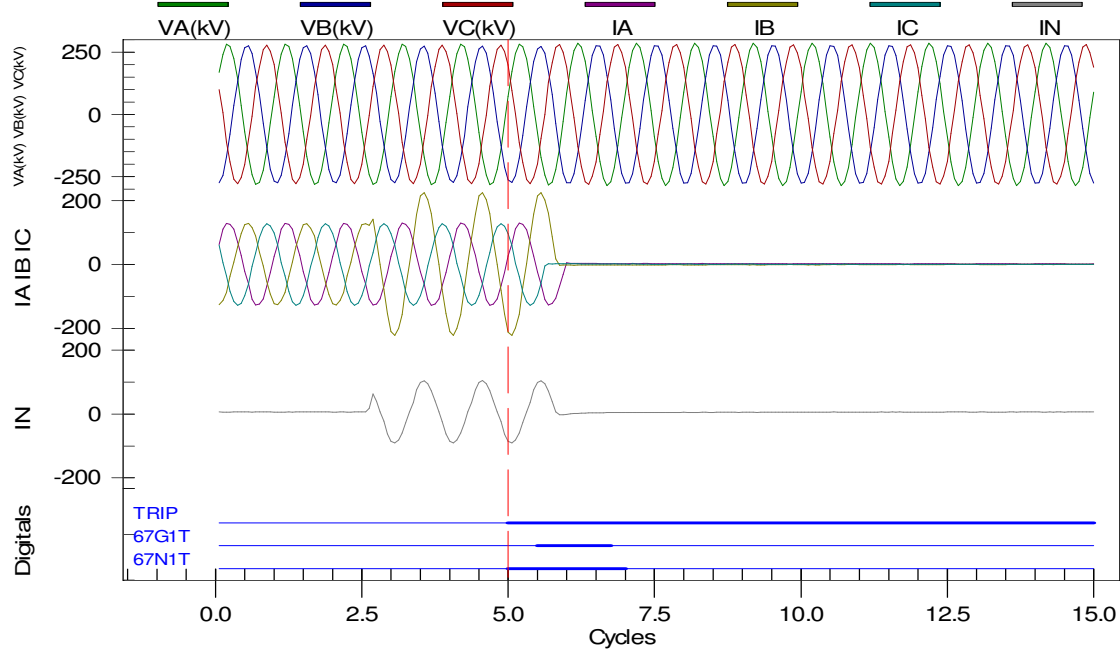
When load increased in Zone 3, the static switch (Relay 2) detected a ground over-current (67N1T) shown in Figure 11d. The static switch then “Opens” after 0.016 seconds (1 cycle) clearing the fault from Zone 3 shown in Figures 11c and 11d.

Figure 11d - Voltages, Currents, and Ground current (IN) at Relay 2 when the fault is detected and cleared by the static switch

After the static switch opened, the breakers in the protection zones (i.e., CB31 in Zone 3, CB41 in Zone 4 and CB51 in Zone 5) remained closed. This was expected, since the fault was isolated and cleared by the static switch.

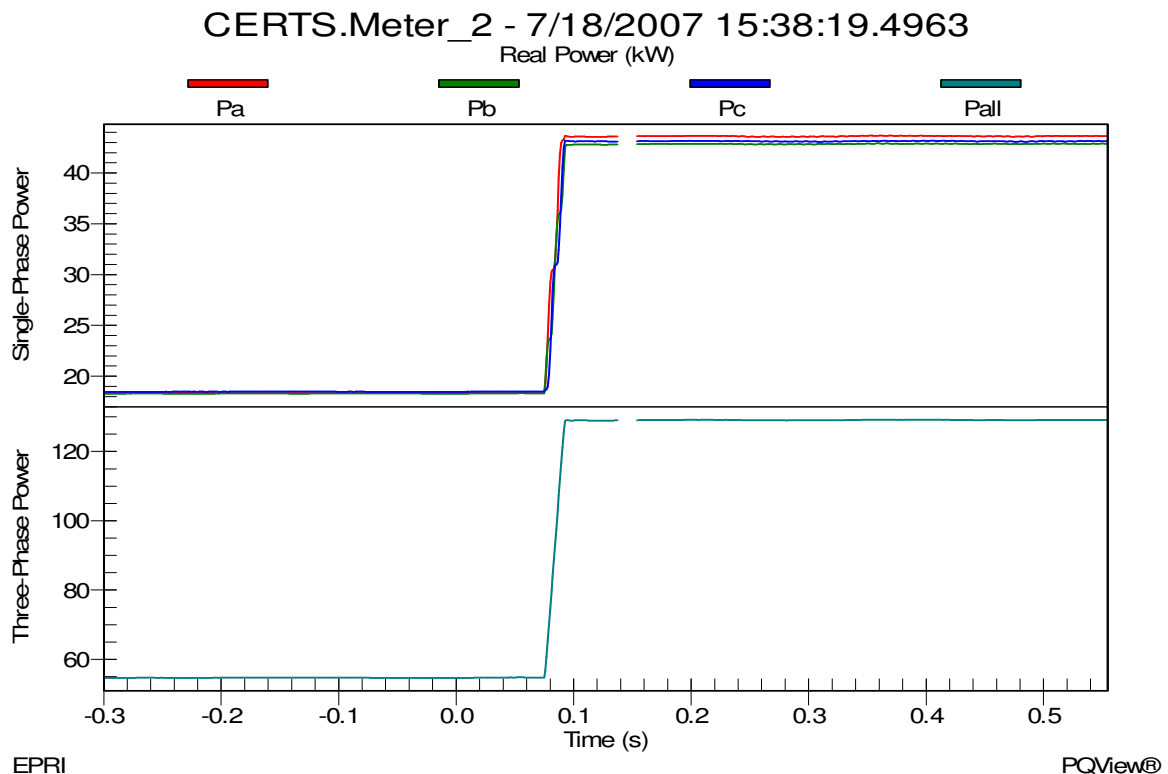
**Figure 12a - Load change when the overload fault was initiated in Zone 5.**

Bed was connected to the utility grid with approximately 55kW at Meter 2. A simulated fault (i.e., Overload Load Bank of 85kW) with the duration set for 99 seconds was initiated in Zone 5 from the DAS Load Control Program. Figure 12a shows when the overload bank was initiated and load in Zone 5 increased from approximately 55kW to 130kW.

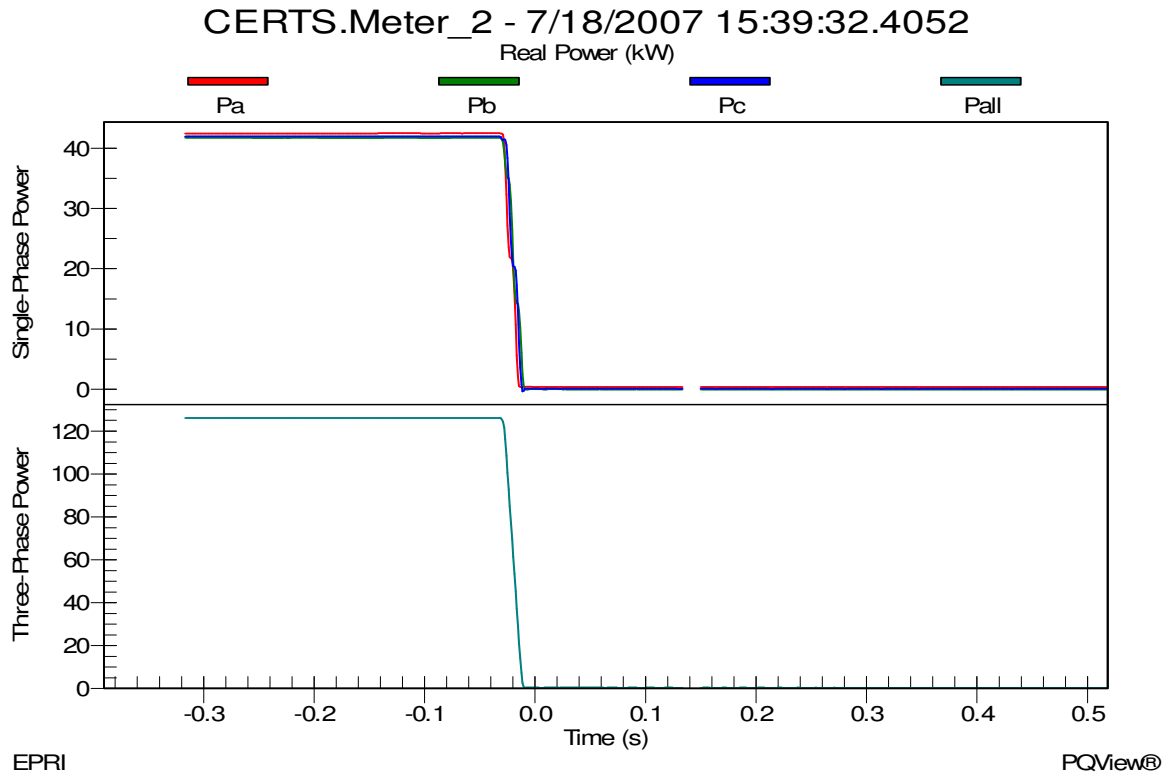
Figure 12b - Load change before/after CB51 opened to isolate and clear the fault in Zone 5.

When the load increased in Zone 5, CB51 internally detected an  $I^2t$  protection event and opened after 72.8 seconds, clearing the fault from Zone 5, as shown in Figure 12b.

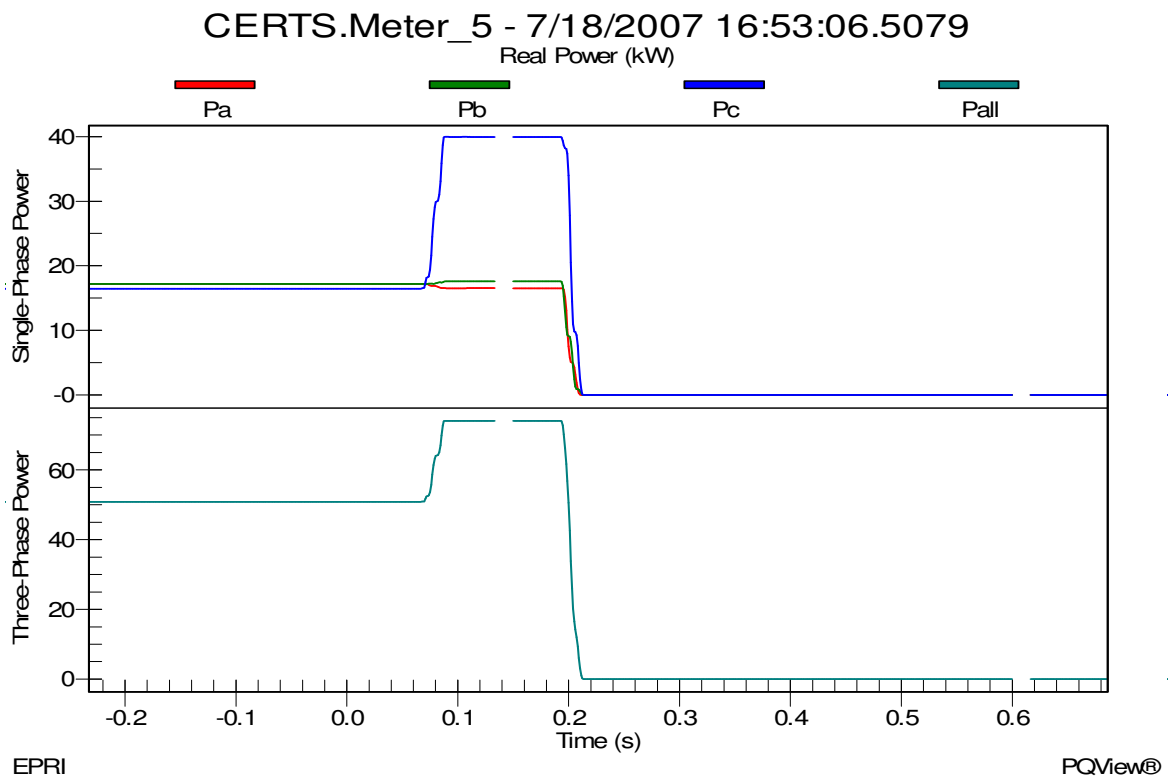
Figure 12c - Load in Zone 5 before/after the single phase-to-ground fault was applied.

Bed was connected to the utility grid with approximately 54kW at Meter 2. A simulated fault (i.e., Overload Load Bank of 28.3kW on C-phase) with a duration set for 10 seconds was initiated to Zone 5 from the DAS Load Control Program. Figure 12c shows when the overload bank was initiated and the load in Zone 5 increased from approximately 51kW to 74kW three-phase power and approximately 16.5kW to 40kW on C-phase. Also, Figure 12ce, shows where the fault is cleared and the load is reduced to 0kW.

When the load increased in Zone 5, Relay 5 detected a negative-sequence over-current (67Q1T) event, shown in Figure 12f. CB51 opened and cleared the fault from Zone 5 shown in Figure 12f. The opening of CB51 was past the end of the recorded relay waveform, but it can be seen that the real power at Meter 5 reduces to zero, shown in Figure 12c.

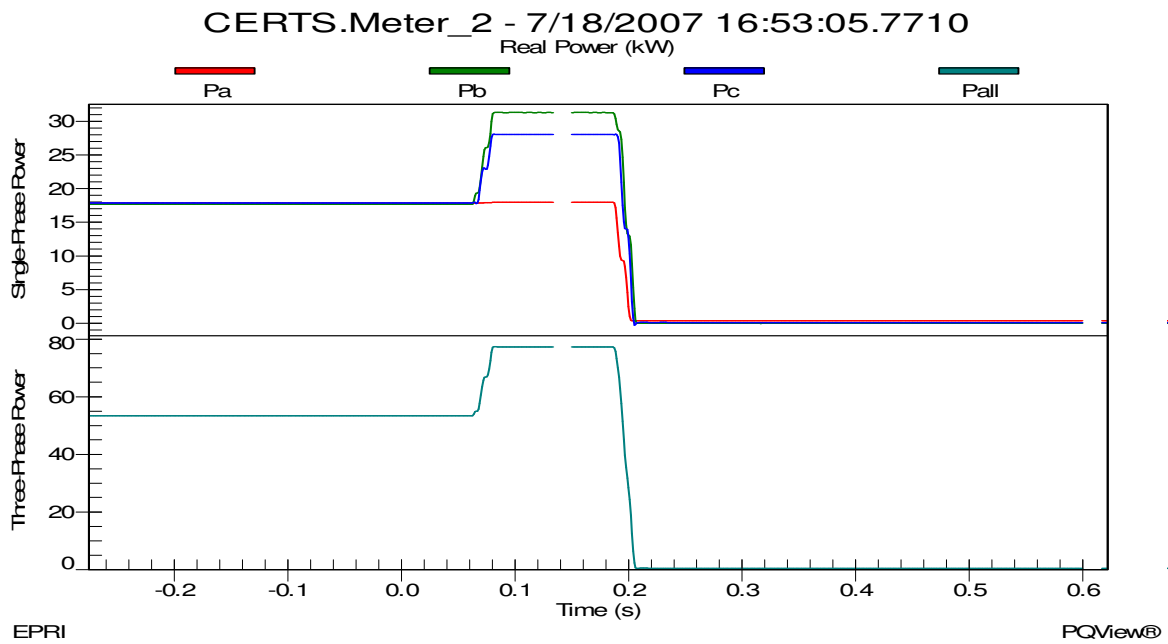
Figure 12d - Load change before/after the single phase-to-ground fault was applied in Zone 5.

From Figure 12d it can be seen at the static switch that the phase C real power appears reduced in magnitude and distributed over both phases B and C. This reduces the sensitivity of the static switch to this type of fault in Zone 5. From Figure 12e it is apparent that the static switch did not operate, since the RMS voltage never collapsed.

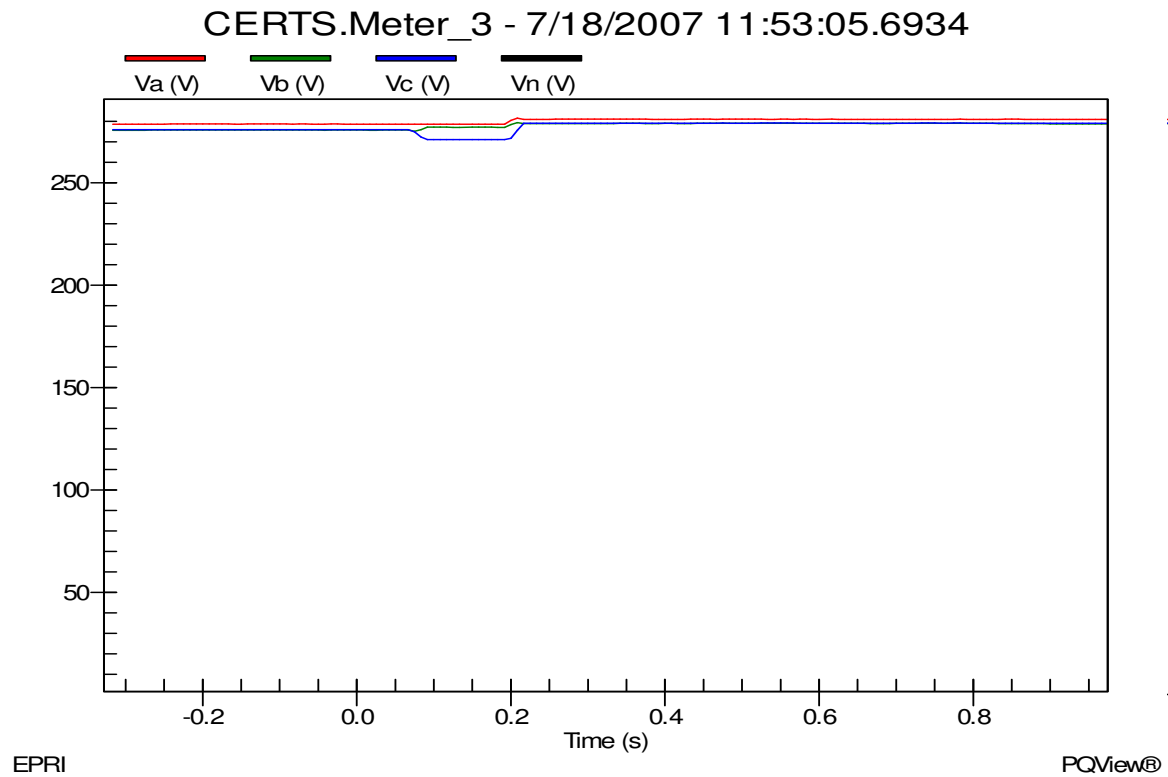
Figure 12e - RMS Voltage in Zone 3 before/after the single phase-to-ground fault was applied

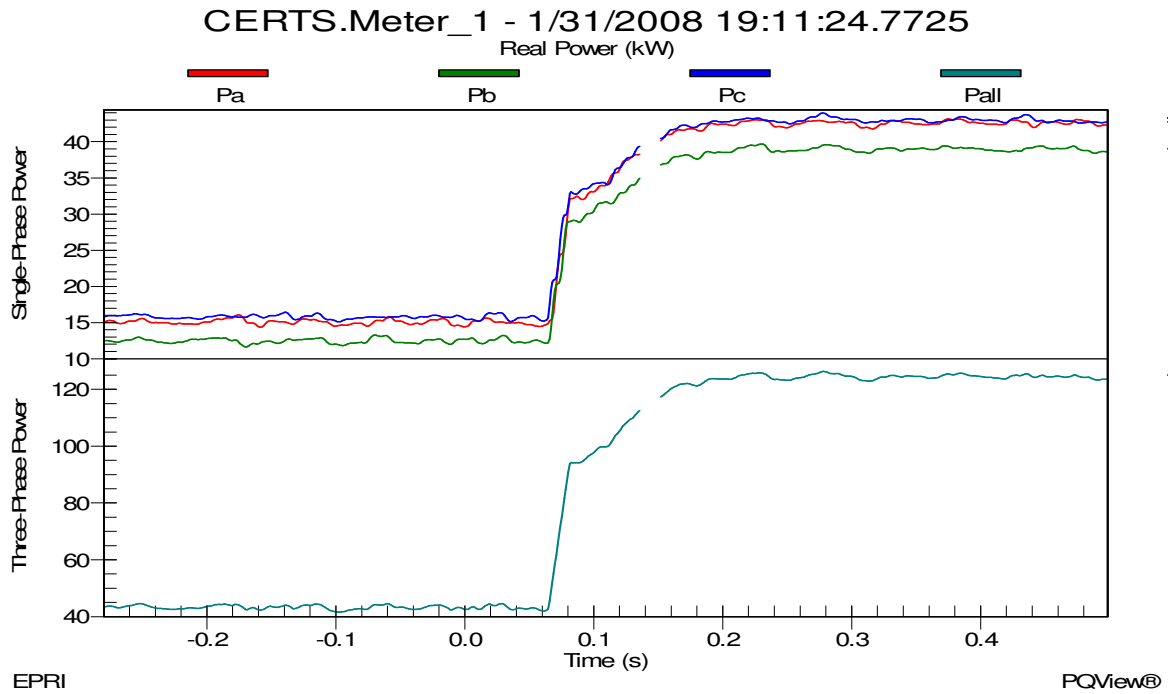
Figure 13a - Power flow at Meter 1 before/after the overload fault was applied.

After both Gen-sets A1 and A2 were running for a few minutes and supplied power to Load Bank 3 and Load Bank 4, the test was started with a “Start” command from the EMS. As soon as the static switch closed and steady-state conditions established, the microgrid was connected to the utility grid with total power flow at Meter 1 equaling approximately 45kW and approximately 5kW at Meter 2. Figure 13a shows when the

overload fault was applied in Zone 4, the load increased from 45kW to approximately 125kW at Meter 1.

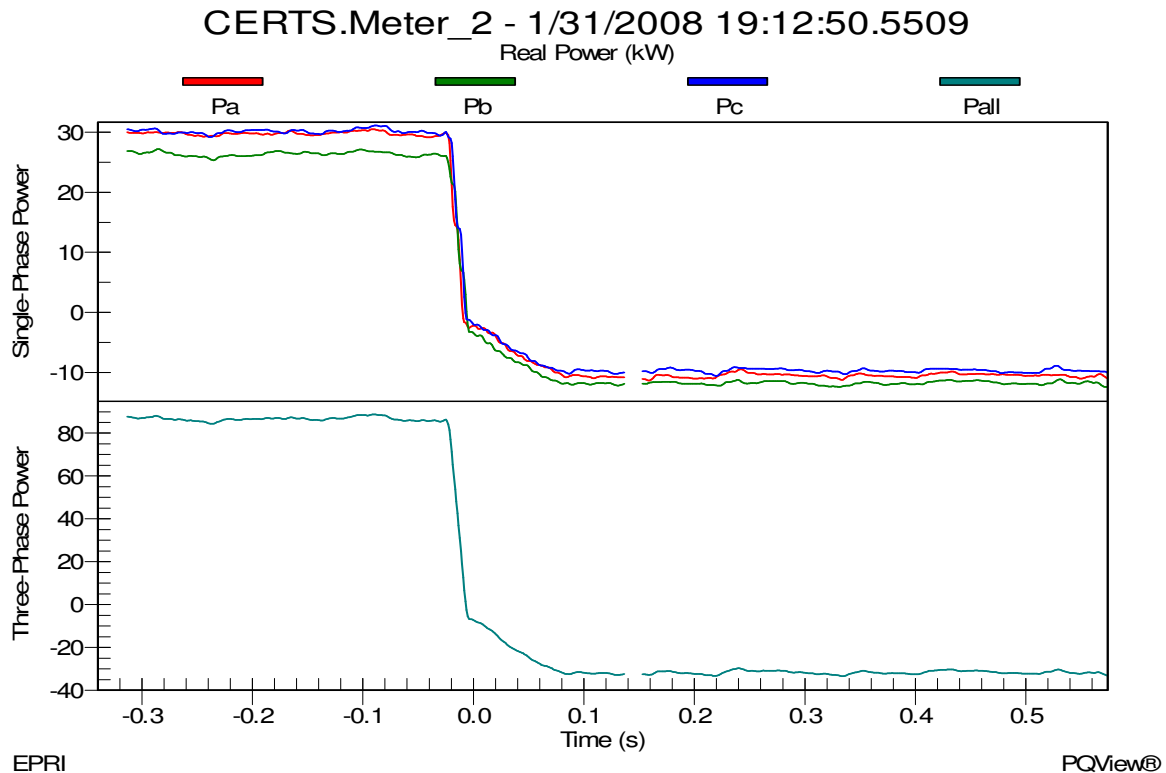
Figure 13b - Power flow at Meter 2 before/after CB41 opened.

Using the DAS Load Control program, the three-phase ground fault was set for a duration of 99 seconds and then initiated. CB41 tripped on an I<sup>2</sup>t protection event in 86 seconds, shown in Figures 13b, which isolated and cleared the fault as expected in Zone 4. Zone 3 and Gen-set A1 remained connected, displacing the load in Zone 6, as shown in Figure 13b with minus 37kW through the static switch. This results in approximately zero load at the PCC, which in-turn caused the static switch to open after 30 seconds due to a reverse power event.

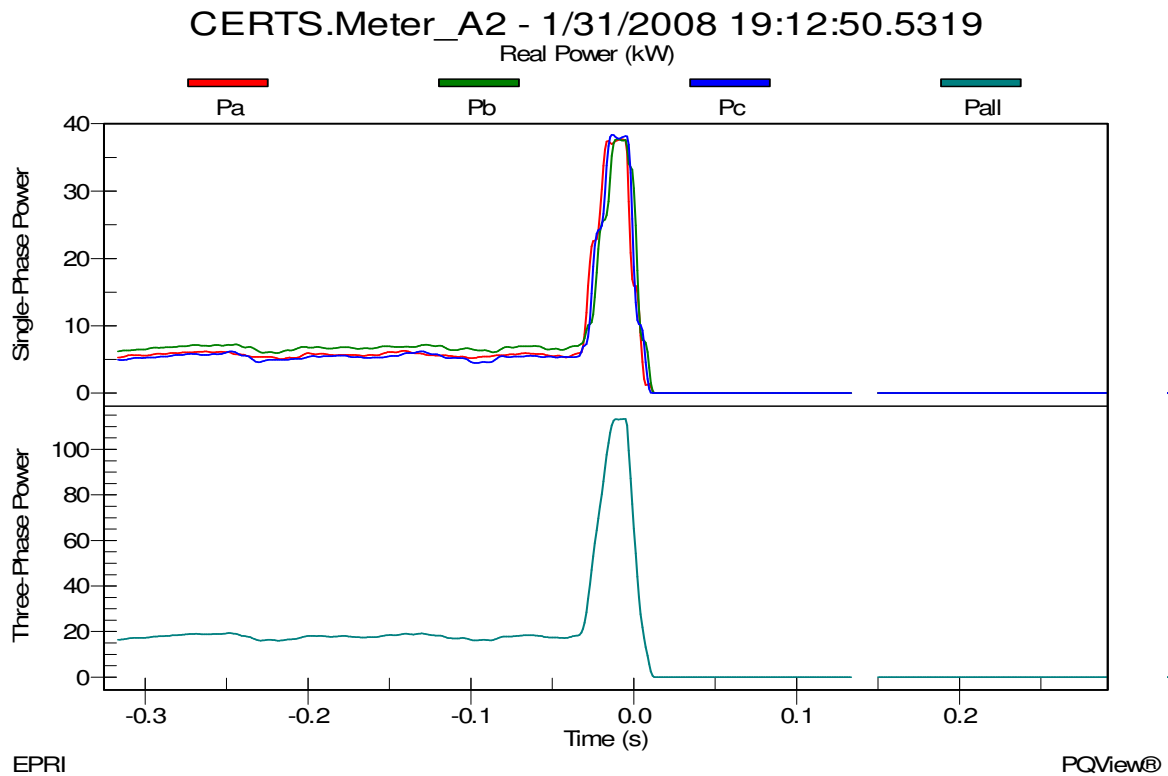
Gen-set A2 shut down 0.2619 seconds (~16 cycles) after CB41 opened to clear the fault, shown in Figure 13c. Gen-set A1 remained online after Gen-set A2 shutdown producing approximately 47kW. Note, in Figure 13d there is an instance where Gen-set A1 drops from approximately 47kW to 22kW, which is due to Load Bank 4 being disconnected

**Figure 13c - Gen-set A2 shutting down after CB41 opens**

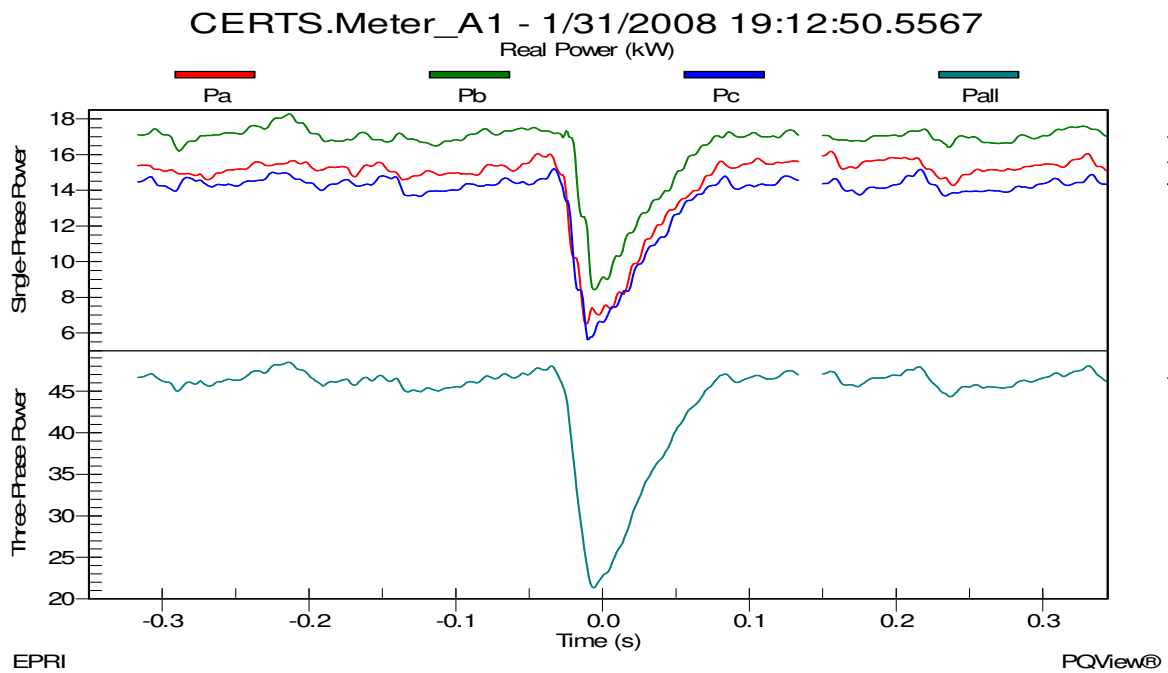
Figure 13d - Gen-set A1 power flow before/after CB41 opened.

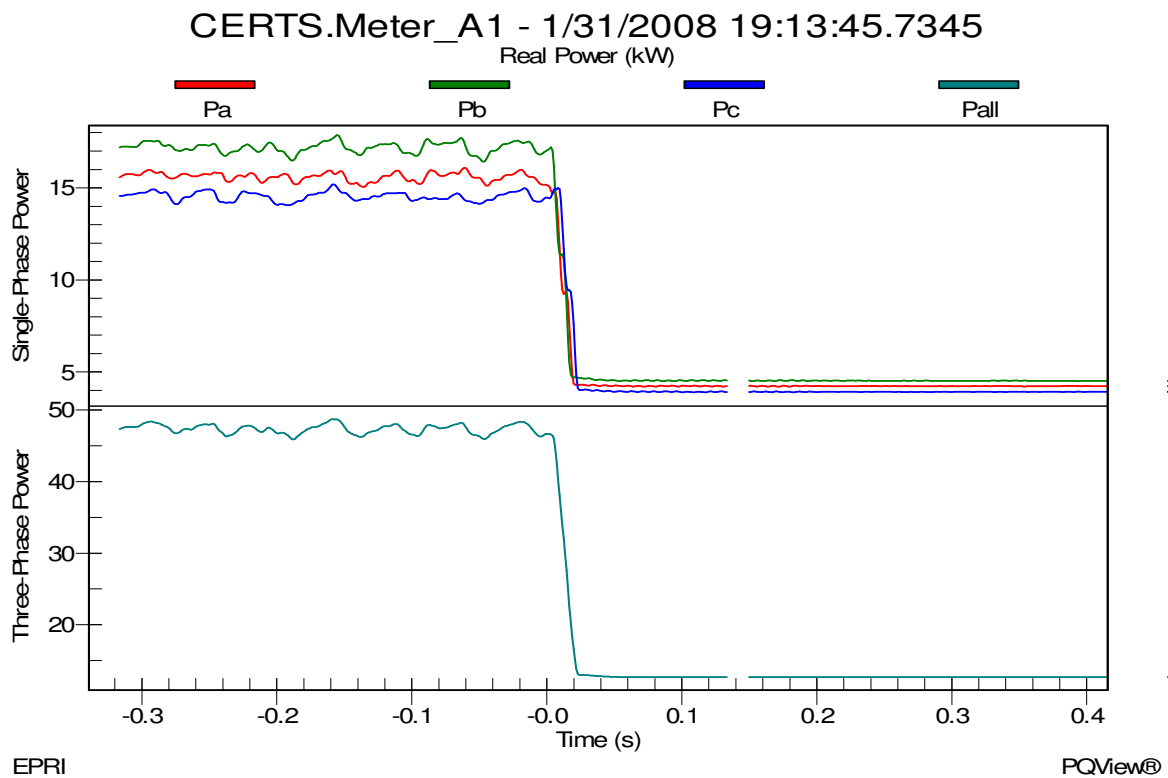
**Figure 13e - Gen-set A1 power flow reducing its output power to approximately 12kW after the static switch opens from a reverse power condition.**

Gen-set A1 dropped its output power from 50kW to 12kW to satisfy the load requirement. The electrical system was stable in both the microgrid and utility grid after CB31 opened and Gen-set A2 shutdown. Gen-set A1 was manually shutdown, all loads and alarms were reset, and equipment was prepared for the next test.

from the microgrid. Since Gen-set A1 was set for a Unit Power Control of 50kW and there was only 10kW worth of load from Load Bank 3 within the microgrid a reverse power flow occurred opening the static switch islanding it from the utility grid. The static switch opened approximately 56.2 seconds after CB41 opened and Gen-set A1 remained online, serving the microgrid load. Figure 13e shows Gen-set A1 picking up the load from Load Bank 3, approximately 12kW after the static switch opened.

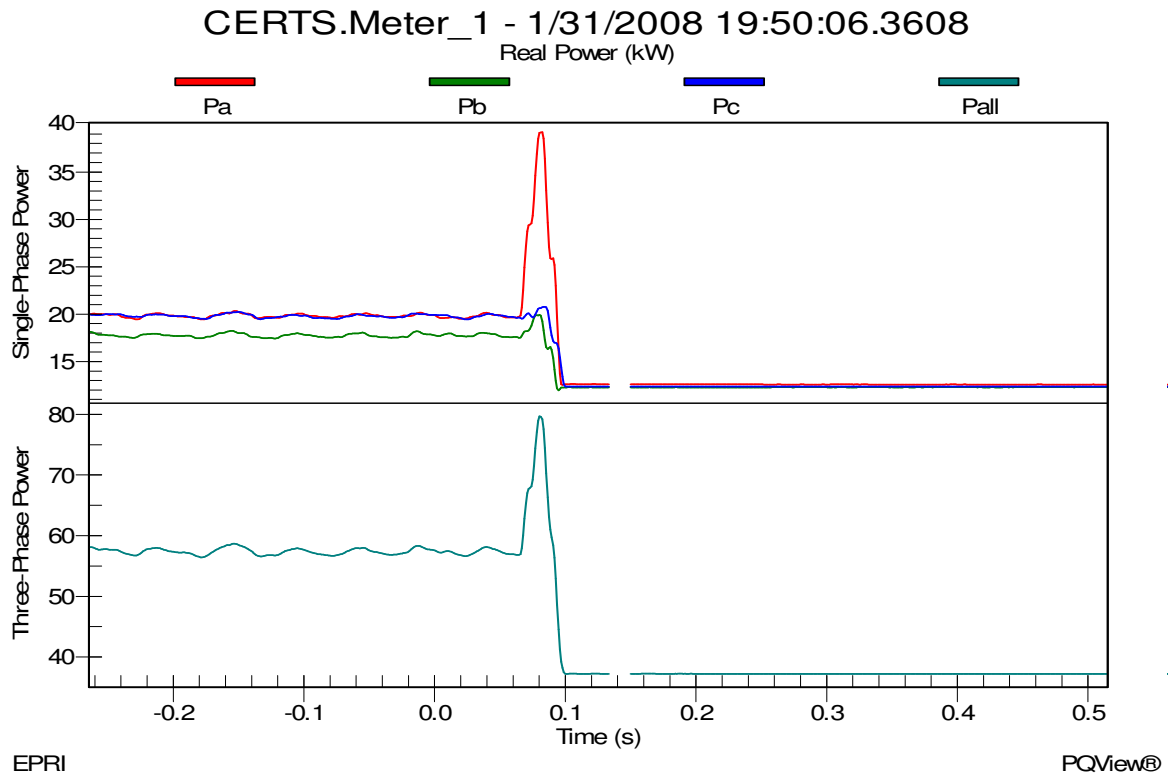
Figure 14a - Power flow in Meter 1 before/after the fault was cleared in Zone 3.

closed and steady-state conditions established, the microgrid and Load Bank 6 were connected to the utility grid with the total power flow at Meter 1 equaling approximately 57.5kW, shown in Figure 14a, and 21kW at Meter 2 shown in Figure 14b before the fault was applied.

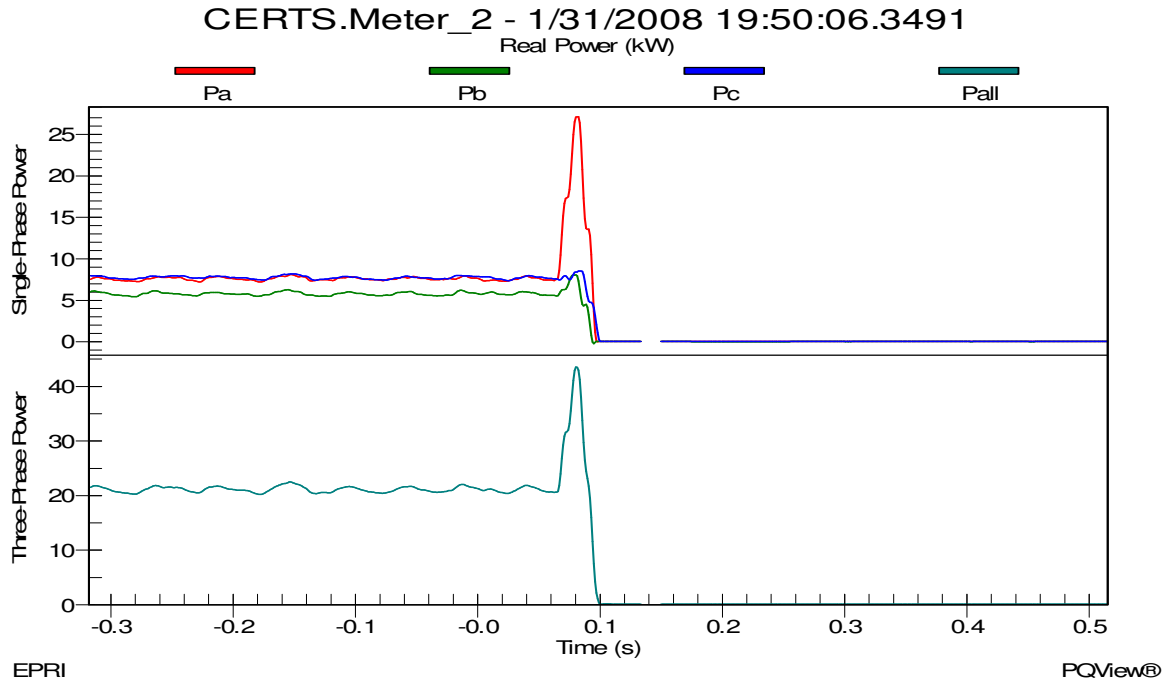
Figure 14b - Power flow in Meter 2 before/after the fault was cleared in Zone 3.
